**TRANSMITTAL
ASSESSMENT OF DAM SAFETY OF
COAL COMBUSTION SURFACE IMPOUNDMENTS
DRAFT INSPECTION REPORT
SITE 30 (BRUCE MANSFIELD)**

DAM SAFETY INSPECTION NOTICE

DEP Office	SWRO- PITTSBURGH	Phone	4124424000	Dam Permit or ID. #	D04-049
Address	400 WATERFRONT DR BH PA 15222			Dam or Project Name	LITTLE BLUE RUN
Owner or Permittee	FIRST ENERGY GENERATION CORPORATION			County	BEAVER
Complete Mailing Address	BRUCE MANFIELD PLANT PO Box 128 SHIPPINGPORT PA 15077-0128			Municipality	GREENE TOWNSHIP
				Take GPS readings at the center of the crest of the dam.	
				Latitude:	40° 37' 40.14" N
				Longitude:	80° 30' 47.79" W

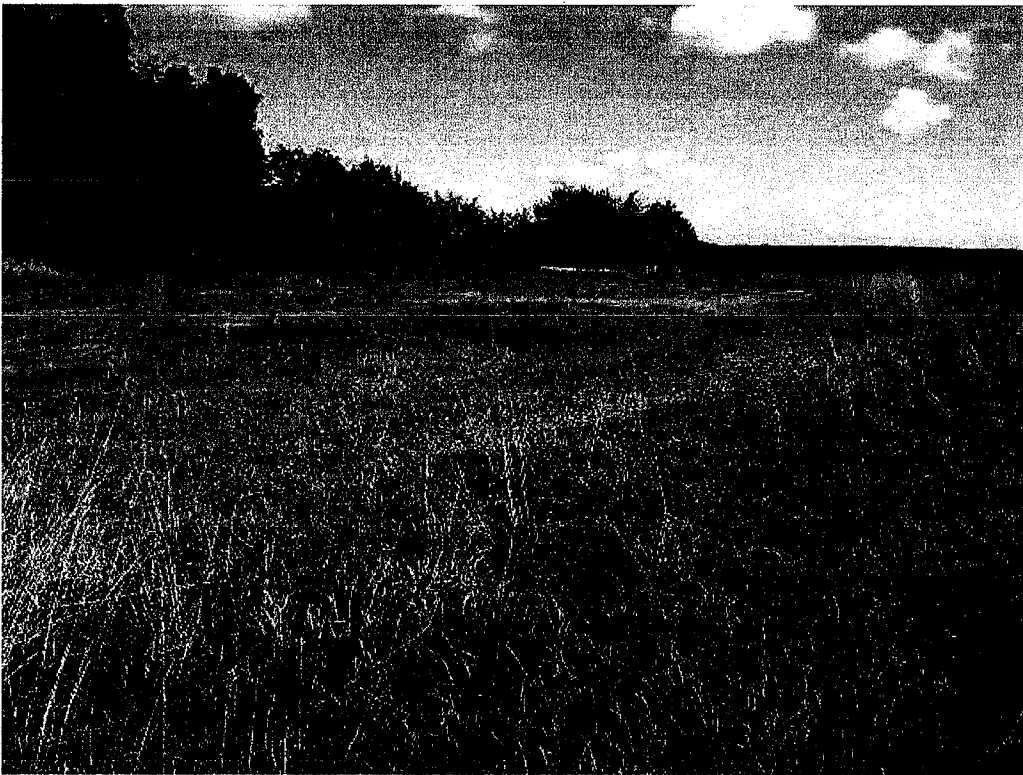
d04-049 9/21/06 area between left primary spillway and emergency spillway

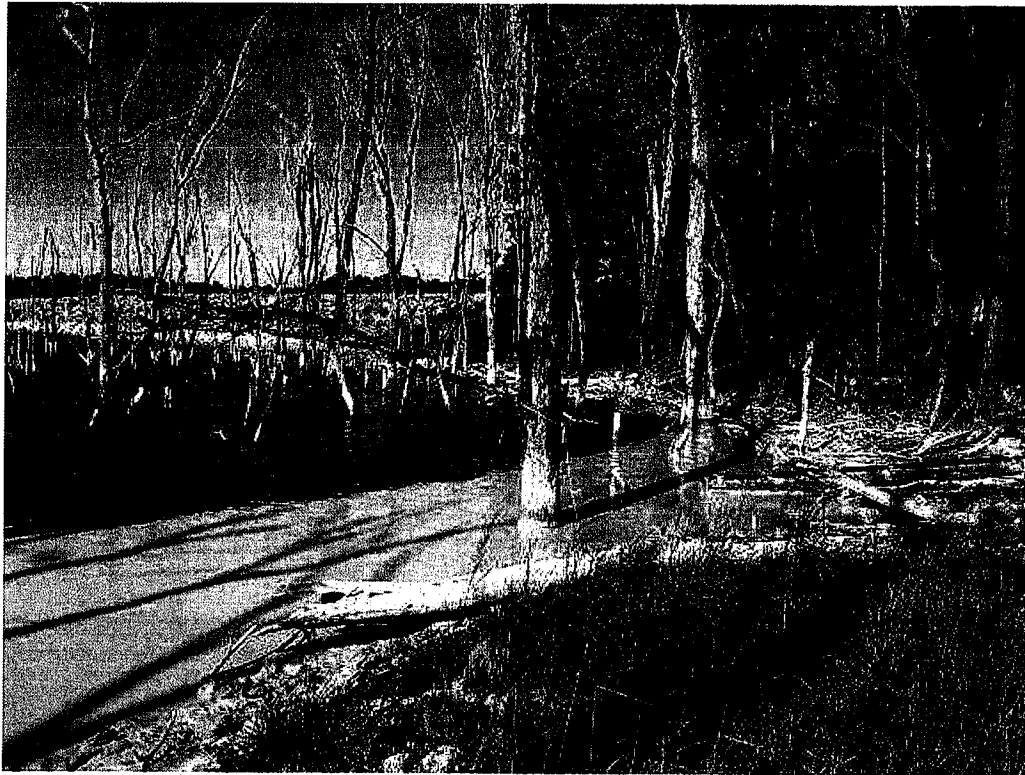
d04-049 9/21/06 approach to right primary spillway

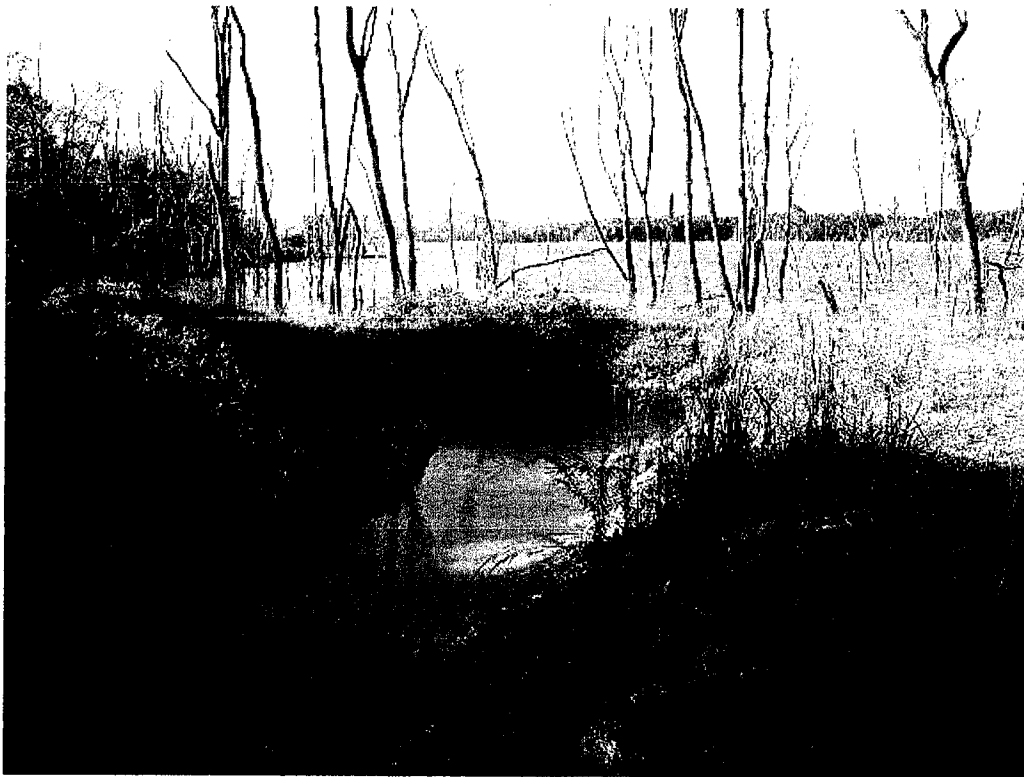
d04-049 9/21/06 approach to right primary spillway

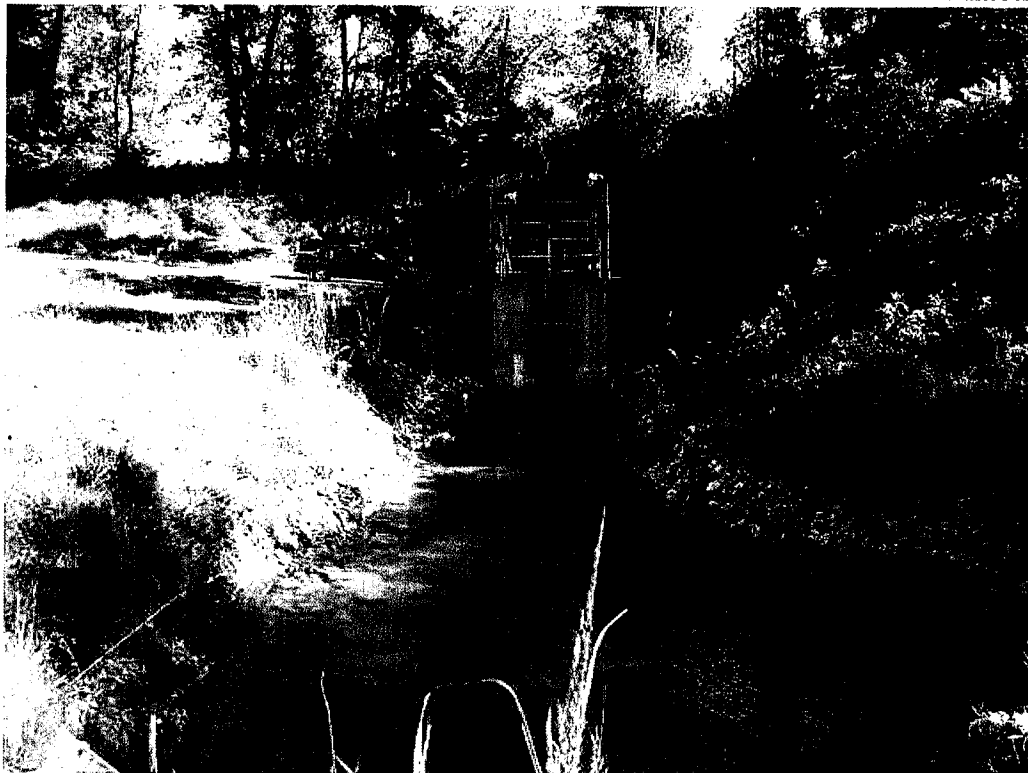
d04-049 9/21/06 right primary spillway intake

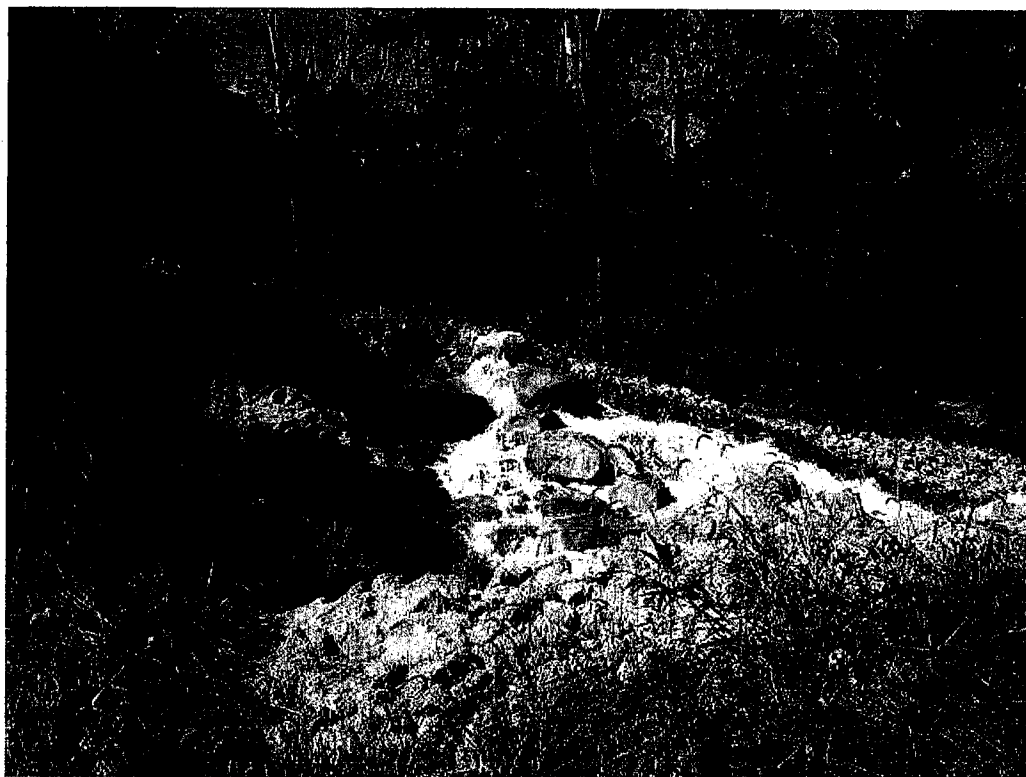
d04-049 9/21/06 right primary spillway outlet

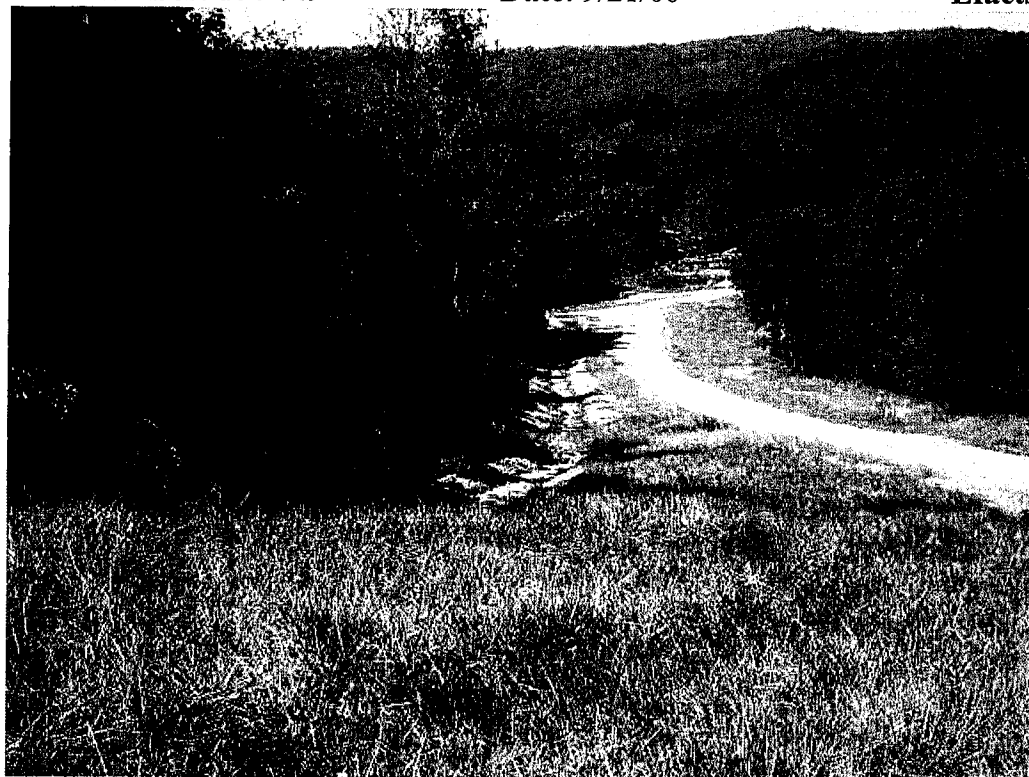
d04-049 9/21/06 right primary spillway wasteway

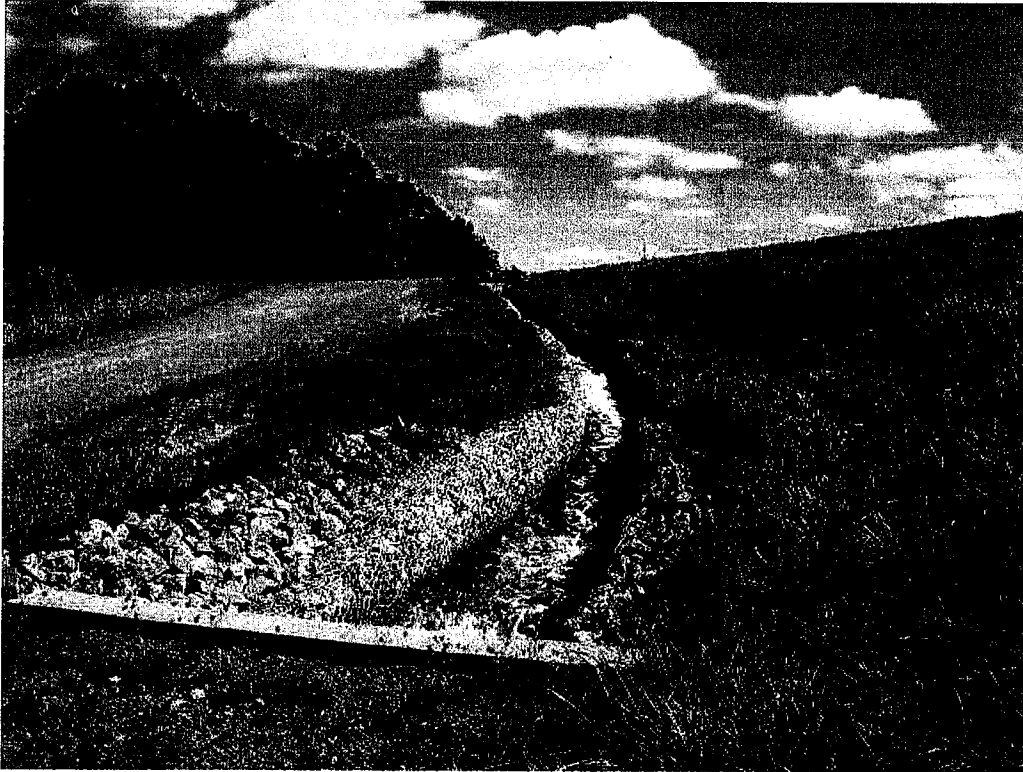
04-049 9/21/06 right primary spillway wasteway

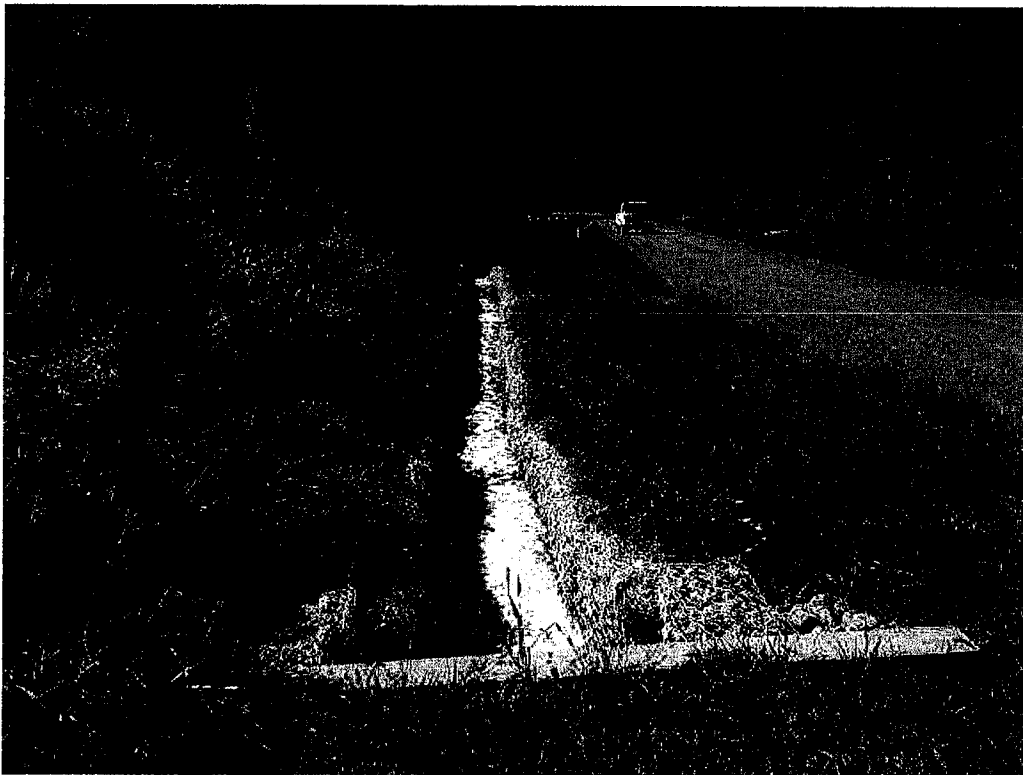
04-049 9/21/06 right primary spillway wasteway

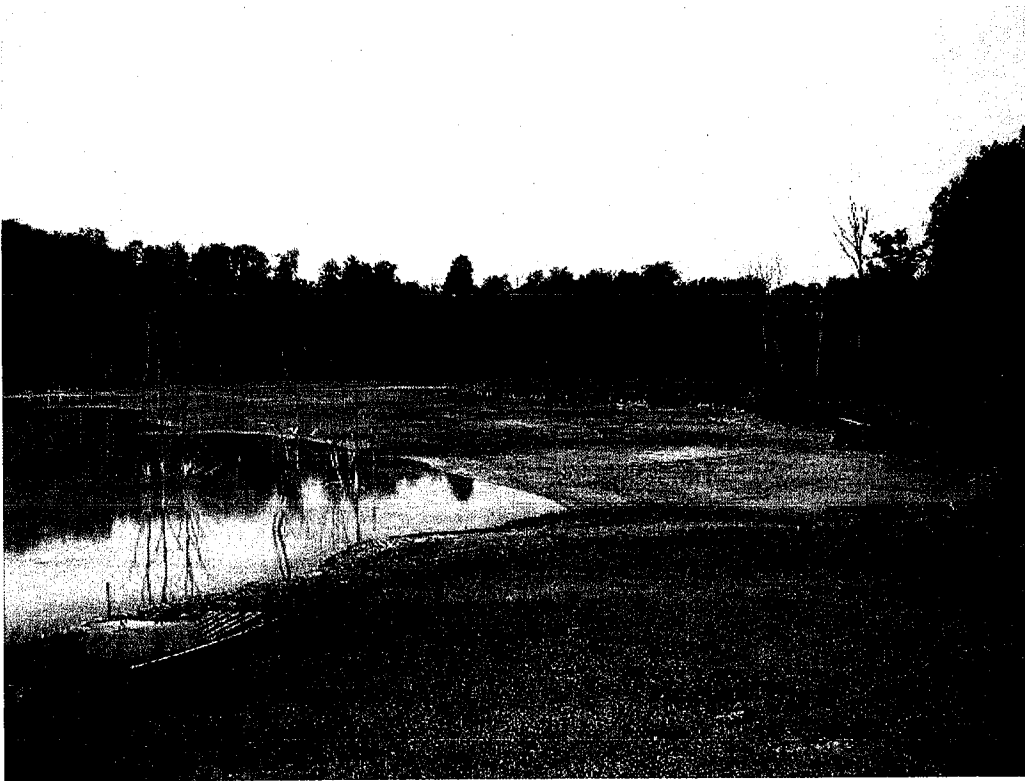
left side of impoundment

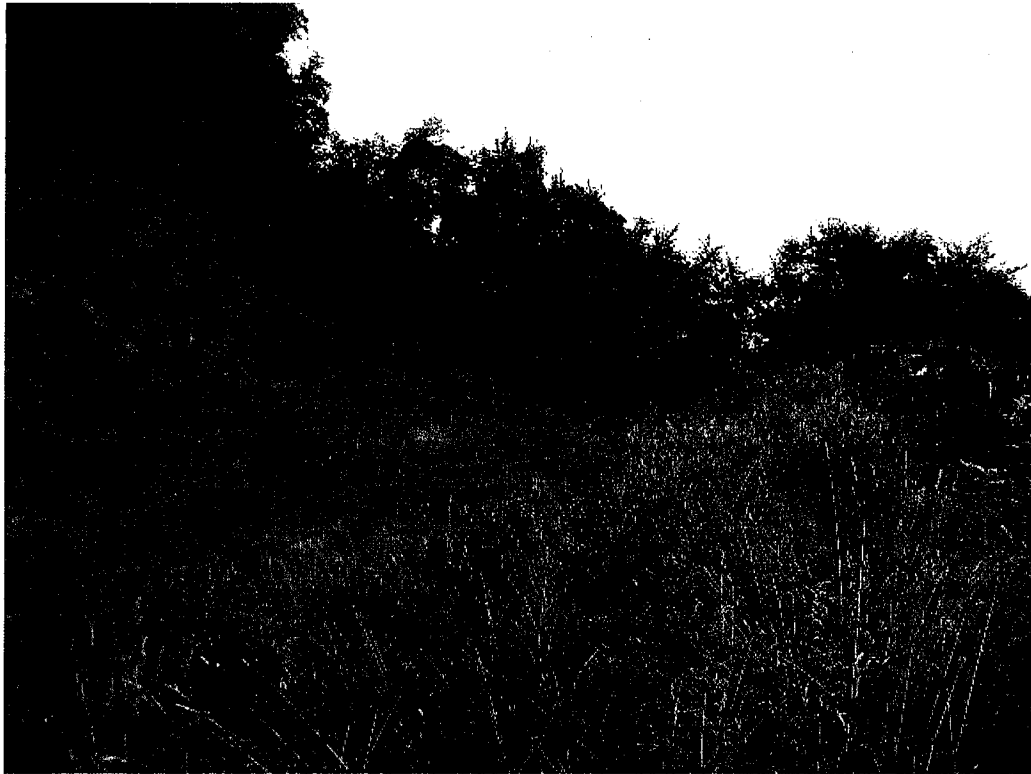
d04-049 8/29/05 emergency spillway as it flows over left abutment

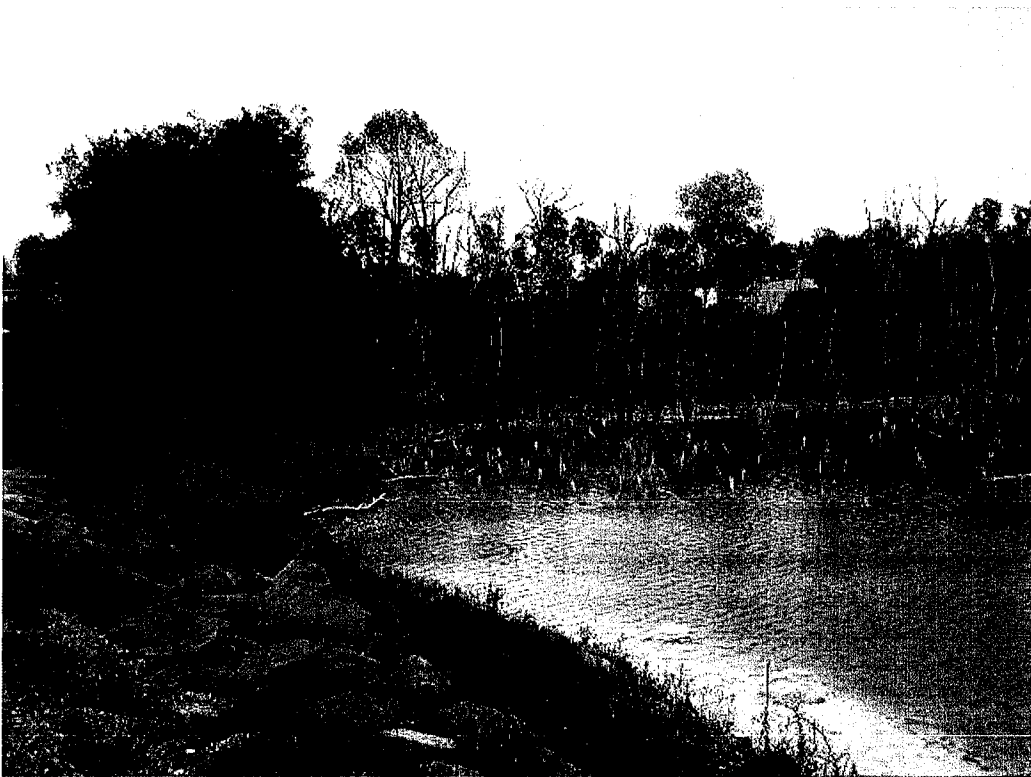
d04-049 8/29/05 right side of impoundment

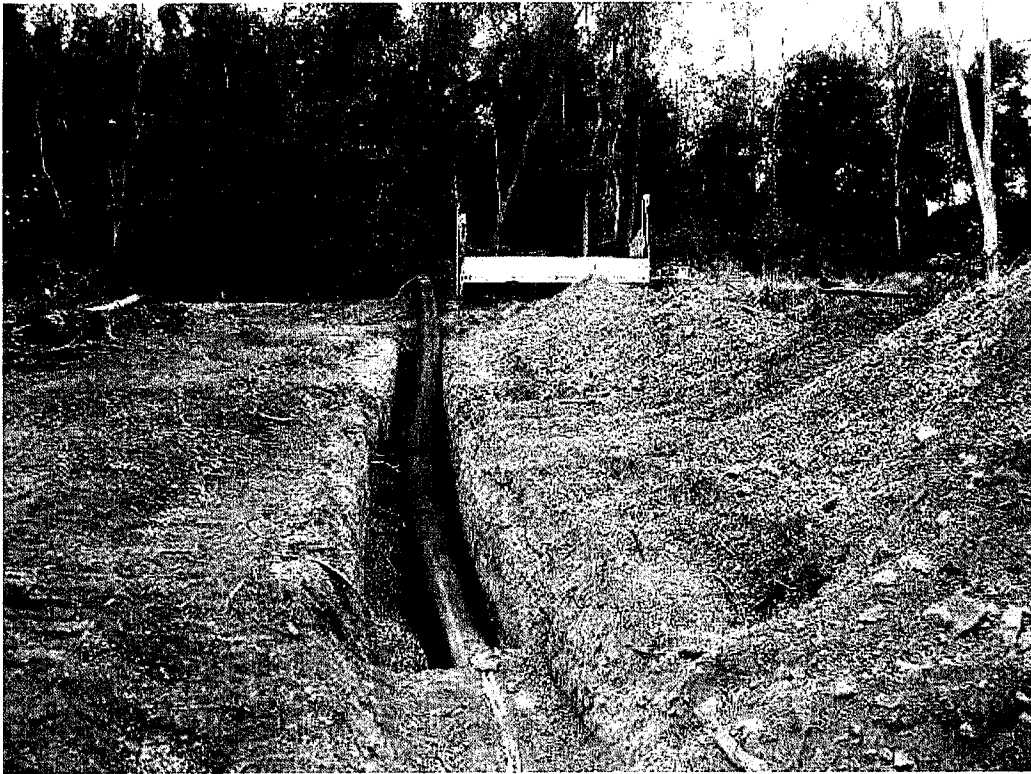
24" HPDE pipe from outlet box at elevation 1000
